HYUNDAI Technical Service Bulletin

Group	ENGINE ELECTRICAL
Number	04-36-004
Date	APRIL, 2004
Model	2001-2003 ELANTRA

2001-2003 ELANTRA ECM REPROGRAMMING FOR WARM AMBIENT COLD START STUMBLE (WACSS) AND ENGINE HESITATION AT APPROXIMATELY 3800 RPM

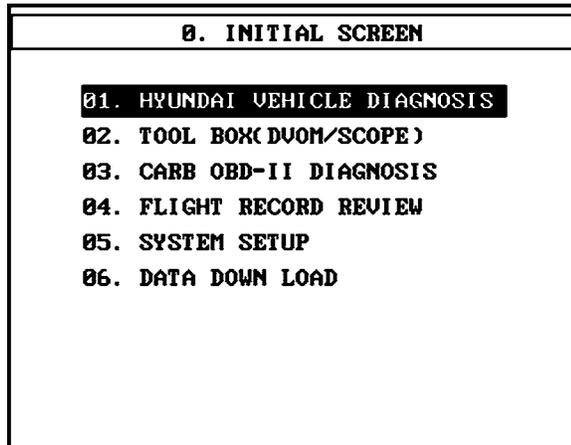
1. Using the Hi-Scan Pro with the SOL System Card Installed, choose the HyundaiDiagnostic Menu.

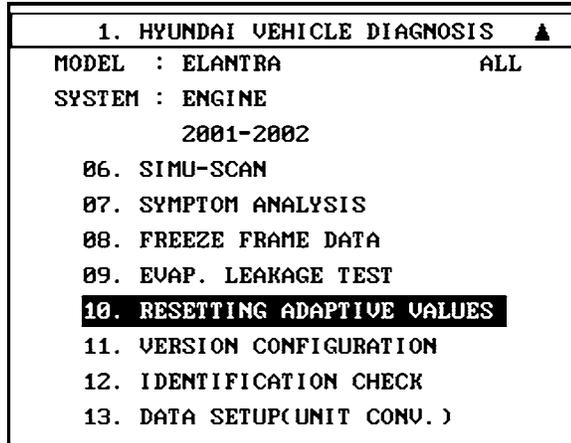
- Choose menu number 10 for "RESETTING ADAPTIVE VALUES."

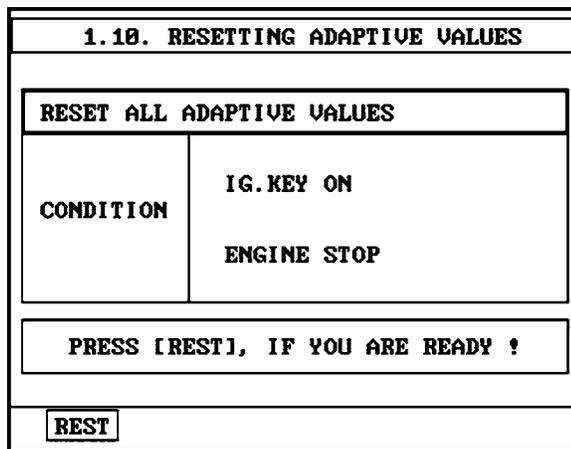
- With the key in the "ON" position and the engine not running, press the F1 button to reset the adaptation values.

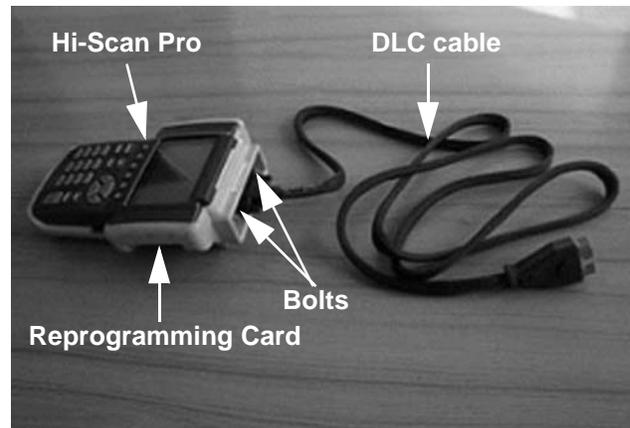
1. Install the Data Link Connector (DLC) cable to the Hi-Scan Pro main body and tighten the 2 bolts securely.
2. Remove the current software card from the Hi-Scan Pro and insert the reprogramming software card with the new ECM program into the Hi-Scan Pro top slot.

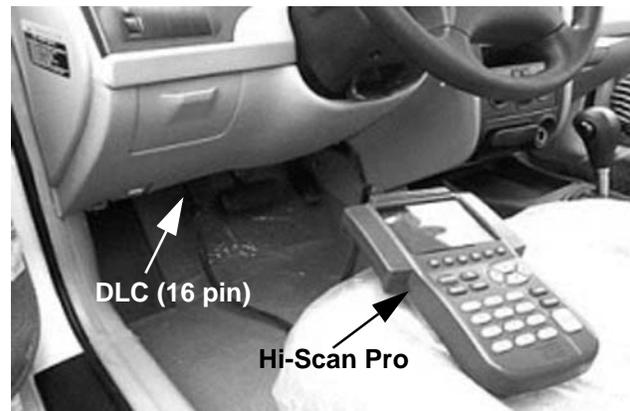
3. Plug the DLC cable from the Hi-Scan Pro into the data link connector (16 pin connector) under the driver's side instrument panel.

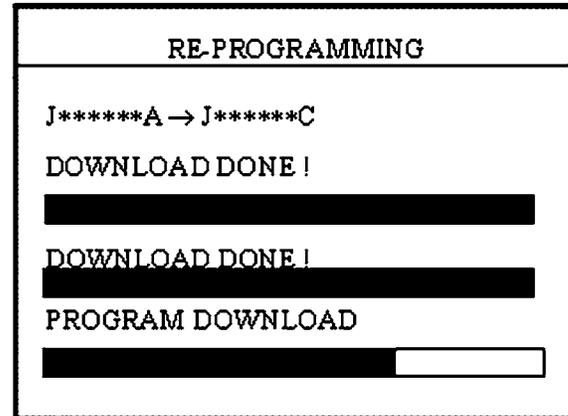
9. The Hi-Scan Pro will establish communication and check the ECM ID. The Hi-Scan Pro will reprogram the ECM automatically.

- The Hi-Scan Pro detects the current ECM ID (affected) and assigns the new ECM ID (target) and displays them on the Hi-Scan Pro screen.
- If the Hi-Scan Pro does not download the program, use the Manual Update Procedure following this section.
- Check the ECM IDs displayed on the Hi-Scan Pro screen to verify that the correct ECM software is being downloaded by referring to the “ECM Specifications Table” shown on page 2 of this bulletin.

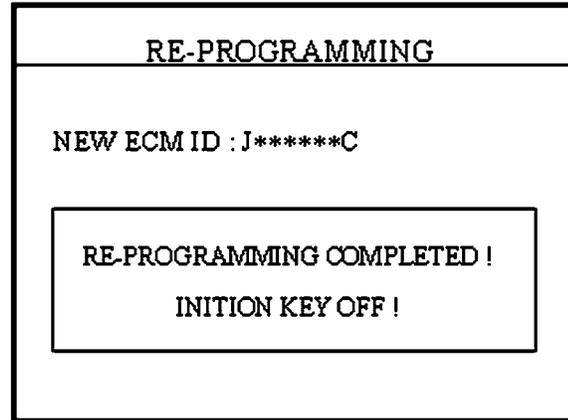
10. When the “**REPROGRAMMING COMPLETED**” message is displayed, the ECM reprogramming process is complete.

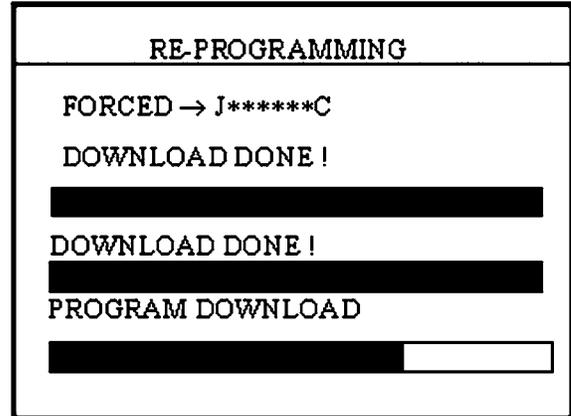
7. Wait until the reprogramming is completed.

NOTE: Check the ECM ID displayed on the Hi-Scan Pro screen to verify that the correct ECM software is being downloaded by referring to the “ECM Specifications Table” shown on page 2 of this bulletin.

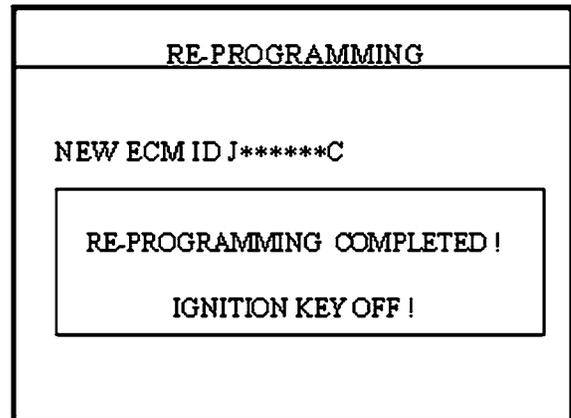
8. When the “**REPROGRAMMING COMPLETED**” message is displayed, the ECM reprogramming process is complete.
